## Wear Testing of Thermally Oxidised Tool Steel Specimens with $\alpha$ -Fe<sub>2</sub>O<sub>3</sub> Layers

### Abstract

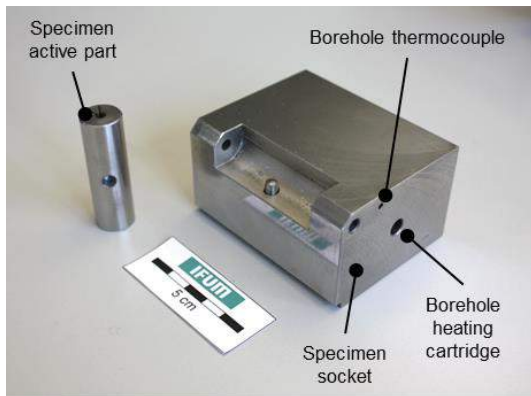
Fig. 1: Wear specimen including an active element (left) and a passive element (right)

The geometry shown in Fig. 1 was developed to ease non-destructive analysis (small active part), provide for economical benefits (separation of active and passive element) and allow for heating (with heating cartridges) and monitoring (with thermocouples) the temperature. By heating the 1.2379 tool steel specimens to  $80\text{ }^{\circ}\text{C} \pm 5\text{ }^{\circ}\text{C}$  it was possible to quickly obtain stationary forming process conditions during the wear investigations. The temperature of about  $80\text{ }^{\circ}\text{C}$  is also typical for commercial forming process with the high strength sheet material (DP600+Z in 0.96 mm) once stationary conditions have been reached. The resulting surface pressure between the specimen and the sheet

The experimental investigations were carried out on a wear test bench by drawing fresh unused material over the specimen's surface with every stroke. This method ensured conditions similar to a forming process in actual production where also fresh material is used for each stroke. A dedicated multiple part wear specimen geometry (Fig. 1) was used for the investigations. For details see Ref. [7].

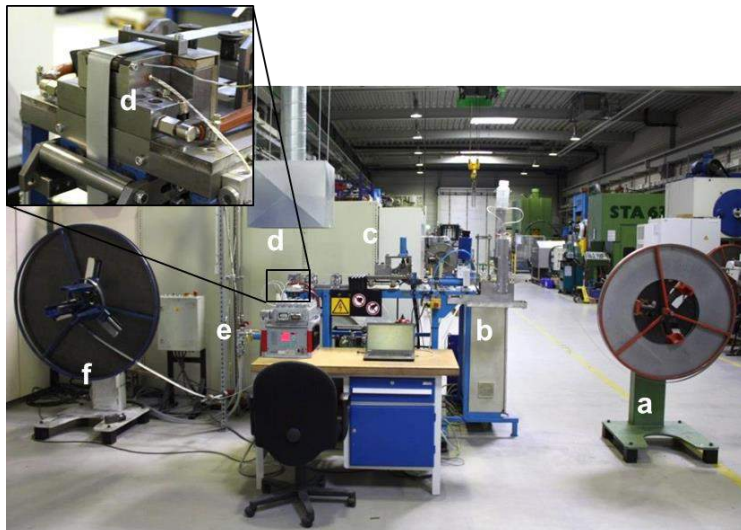
Fig. 2: left picture: Wear test bench with relevant units; a) decoiler, b) cleaning station, c) counter slide, d) specimen, e) pulling slide, f) coiler; right picture: principle of wear test bench

metal was determined by using pressure indicating films (Fujifilm HS - High Pressure Prescale) as reported in [6]. The wear specimen was mounted on the wear test bench shown in Fig. 2. The test bench is supplied with material from a coil. Fresh material is provided with each stroke from the decoiler (a). After decoiling, the material was cleaned from prelube oil (b). The drawing of the material over the drawing radius of the specimen (d) is realised on the test bench by using a counter (c) and a pulling slide (e). The counter force  $F_{\text{counter}}$  can be adjusted by the operator while the pulling force  $F_{\text{pulling}}$  is a resulting force which has to be higher than the adjusted counter force. In this way, the material is drawn over the specimens and finally fed to the coiler (f). During the forming process the forces as well as the displacements of the counter and pulling slide were recorded. For measuring the forces, a miniature load cell (HBM U9C) was used. The U9C load cell can be used for the measurement of tensile as well as compressive forces, which makes the set-up robust against backstrokes at the end of each cycle. The displacements of the counter and pulling slide were measured by using miniature wire sensors (Micro-Epsilon WPS-500-MK30).

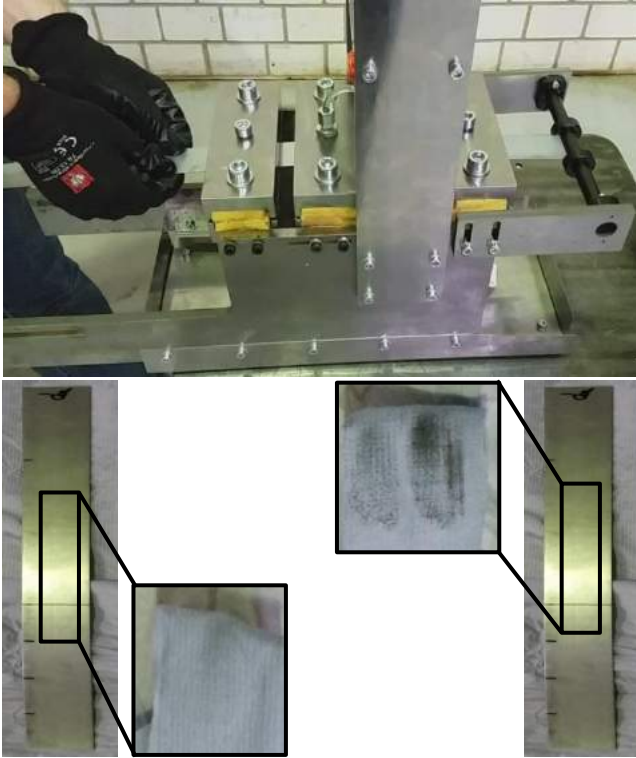
Fig. 3: Cleaning station without air nozzles (upper picture); wipe test before cleaning (bottom right picture); wipe test after cleaning (bottom left picture)

The wipe test, depicted in Fig. 3, shows the presence of significant macroscopic contamination of the sheet metal before cleaning. This can be attributed to the prelube oils which are used in commercial sheet metal production for corrosion protection. The wipe test in the left bottom picture shows a macroscopically clean sheet metal surface after passing the cleaning station within the first three cleaning steps. During the investigations the fresh material was continuously cleaned in the cleaning station. The cleanliness of the sheet metal surface was regularly manually checked with wipe tests. In case of detectable contaminations, the sponges of the station were cleaned or if necessary renewed.

For the present study, the material was cleaned from prelubes before forming (cf. Fig. 3). The cleaning station used purges the material in four stages from both sides:

The macroscopic contaminations present on the sheet metal before and after cleaning were examined with a wipe test as shown in Fig. 3.

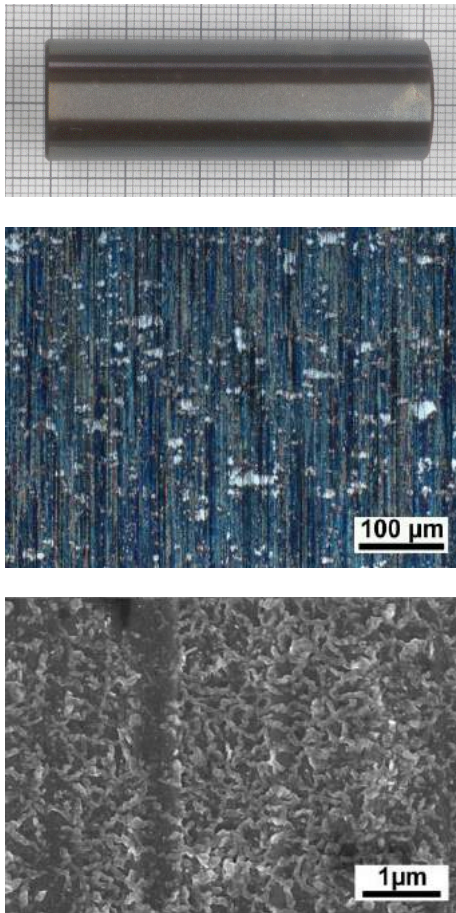
In Fig. 4 an untested specimen is shown at three magnifications. The top image in Fig. 4 shows an oxidised specimen with  $\alpha$ -Fe<sub>2</sub>O<sub>3</sub> layer prior to testing. The whole surface of the specimen has a red/blue discolouration as a visible result of the surface oxidation [1]. A higher magnification with a light microscope (middle picture in Fig. 4) reveals that not all of the surface is covered with the oxide layer. The highest magnification in Fig. 4 (bottom image) reveals the microstructure of the oxide layer. The  $\alpha$ -Fe<sub>2</sub>O<sub>3</sub> layer looks like an arrangement of long polymer chains. The layer is covering the largest part of the section shown, but there are also other uncoated areas.

The coverage of the surface with  $\alpha$ -Fe<sub>2</sub>O<sub>3</sub> strongly depends on the local composition of the substrate. The investigated hardened tool steel (1.2379) has a high chromium content of approx. 12 wt.-% and chromium rich precipitations with different sizes could be detected by SEM-EDX. Surface areas that featured precipitations were usually not covered by the  $\alpha$ -Fe<sub>2</sub>O<sub>3</sub> unless these were very small. Thus, it can be reasoned that the metallic sparkling areas in the top image of Fig. 4 are uncoated chromium rich areas.

Fig. 4: Selectively oxidised  $\alpha\text{-Fe}_2\text{O}_3$  specimen. Top: photo of untested specimen; mid position: digital light microscopic image; bottom: SEM image

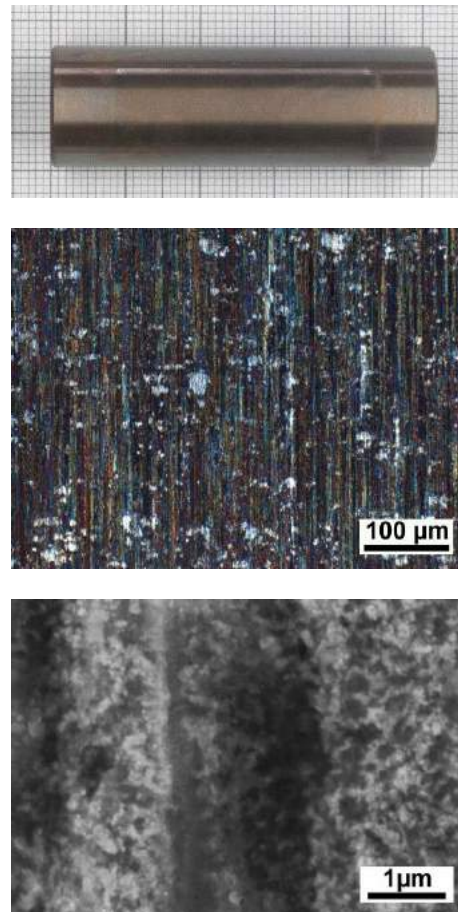
Depending on the number of test cycles the surface of the specimens changed after the wear tests. In Fig. 5 the tested specimen A1 is shown after 100 strokes. The photo (top picture) in Fig. 5 presents the macroscopic appearance of the specimen after testing. While in the bending area of the sheet metal ( $0^\circ$  angle) a layer thinning can be seen, the evaluated area ( $45^\circ$  angle) shows no significant changes on the surface on the macroscopic scale. In addition, slight marks on the left and right side in the contact area with the sheet metal can be seen in the photo in Fig. 5. These are results of the sheet metal burr cutting into the surface. This phenomenon is increasing with the number of strokes but not relevant in the present context because in commercial deep drawing operations such contact conditions are not present.

The light microscopic image of specimen A1 (middle image Fig. 5) only shows slight changes as compared to the light microscopic image of the untested specimen (Fig. 4). Only a few additional scratches along the sliding direction (vertical in the image) can be seen. Furthermore metallic sparkling areas are now visible and it seems that the size of these areas has also increased. It can be assumed that their higher fraction is a result of a partial removal of the  $\alpha\text{-Fe}_2\text{O}_3$  structure. The  $\alpha\text{-Fe}_2\text{O}_3$  also covered the edges of chromium rich precipitations. This leads to the conclusion that the increased fraction of the oxide-free areas can be reasoned by the reduced bonding of the oxide to the substrate at these chromium rich areas. In the SEM image in Fig. 5 (bottom picture)

the surface appears very different, as compared to the SEM image of the untested specimen (Fig. 4). The structure of the oxide layer seems to be smoothed and rounded but is still visible.

Fig. 5: Selectively oxidised  $\alpha\text{-Fe}_2\text{O}_3$  specimen after 100 strokes; top: photo of tested specimen; mid position: digital light microscopic image; bottom: SEM image

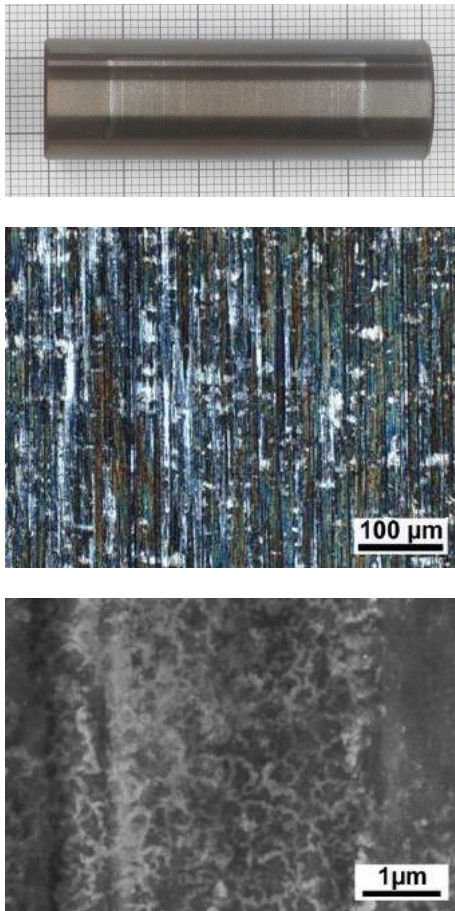
After a substantial increase of the number of strokes to 5000 a thinning of the  $\alpha\text{-Fe}_2\text{O}_3$  layer can be seen clearly at each magnification (Fig. 6). The photo in Fig. 6 (top) reveals that the layer has become thinner over the whole contact area. But even after 5000 strokes a remaining layer can be seen clearly also in light microscopic image (middle). In addition to the layer thinning the middle image shows scoring in the drawing direction. Also zinc pick-up from the hot dip galvanized sheet metal used was detected by EDX. The SEM image in Fig. 6 (bottom) clearly shows features that are an evidence for the existence of  $\alpha\text{-Fe}_2\text{O}_3$  on the surface.

Fig. 6: Selectively oxidised  $\alpha$ -Fe<sub>2</sub>O<sub>3</sub> specimen after 5000 strokes; top: photo of tested specimen; mid position: digital light microscopic image; bottom: SEM image
